1976年唐山大地震 房屋建筑震害图片集

中国建筑科学研究院 编

BUILDING DAMAGE PHOTO ALBUM

COMPILED BY CHINA ACADEMY OF BUILDING RESEARCH

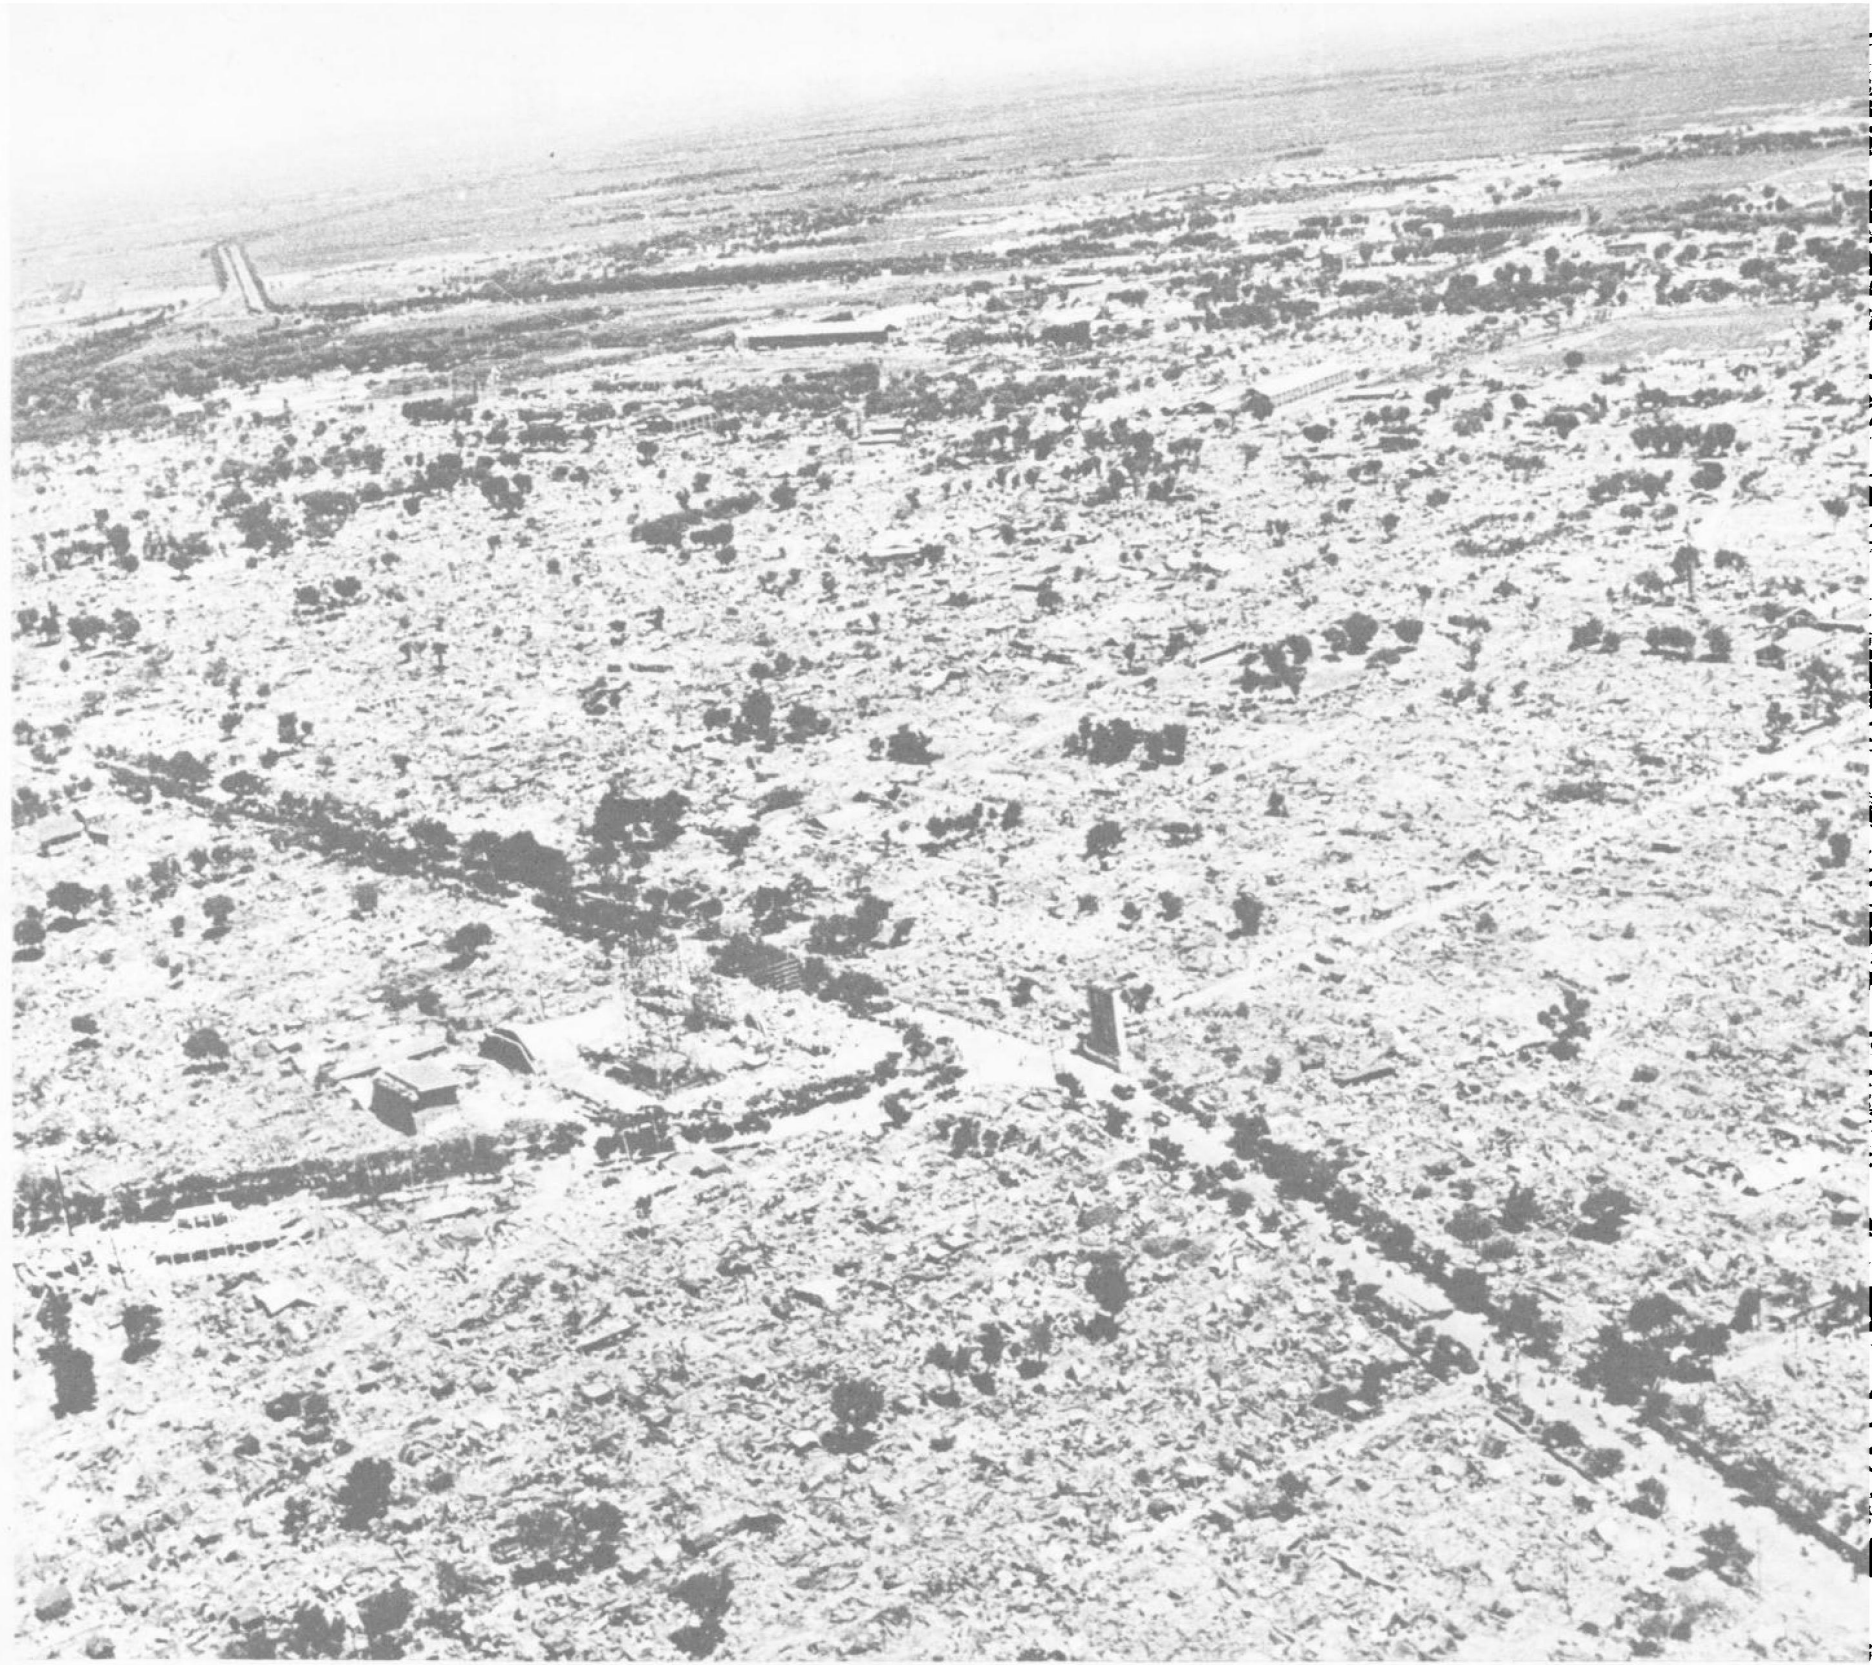
1—3 震后的唐山市路南区，建筑荡然无存，成了一片废墟（11度区）。

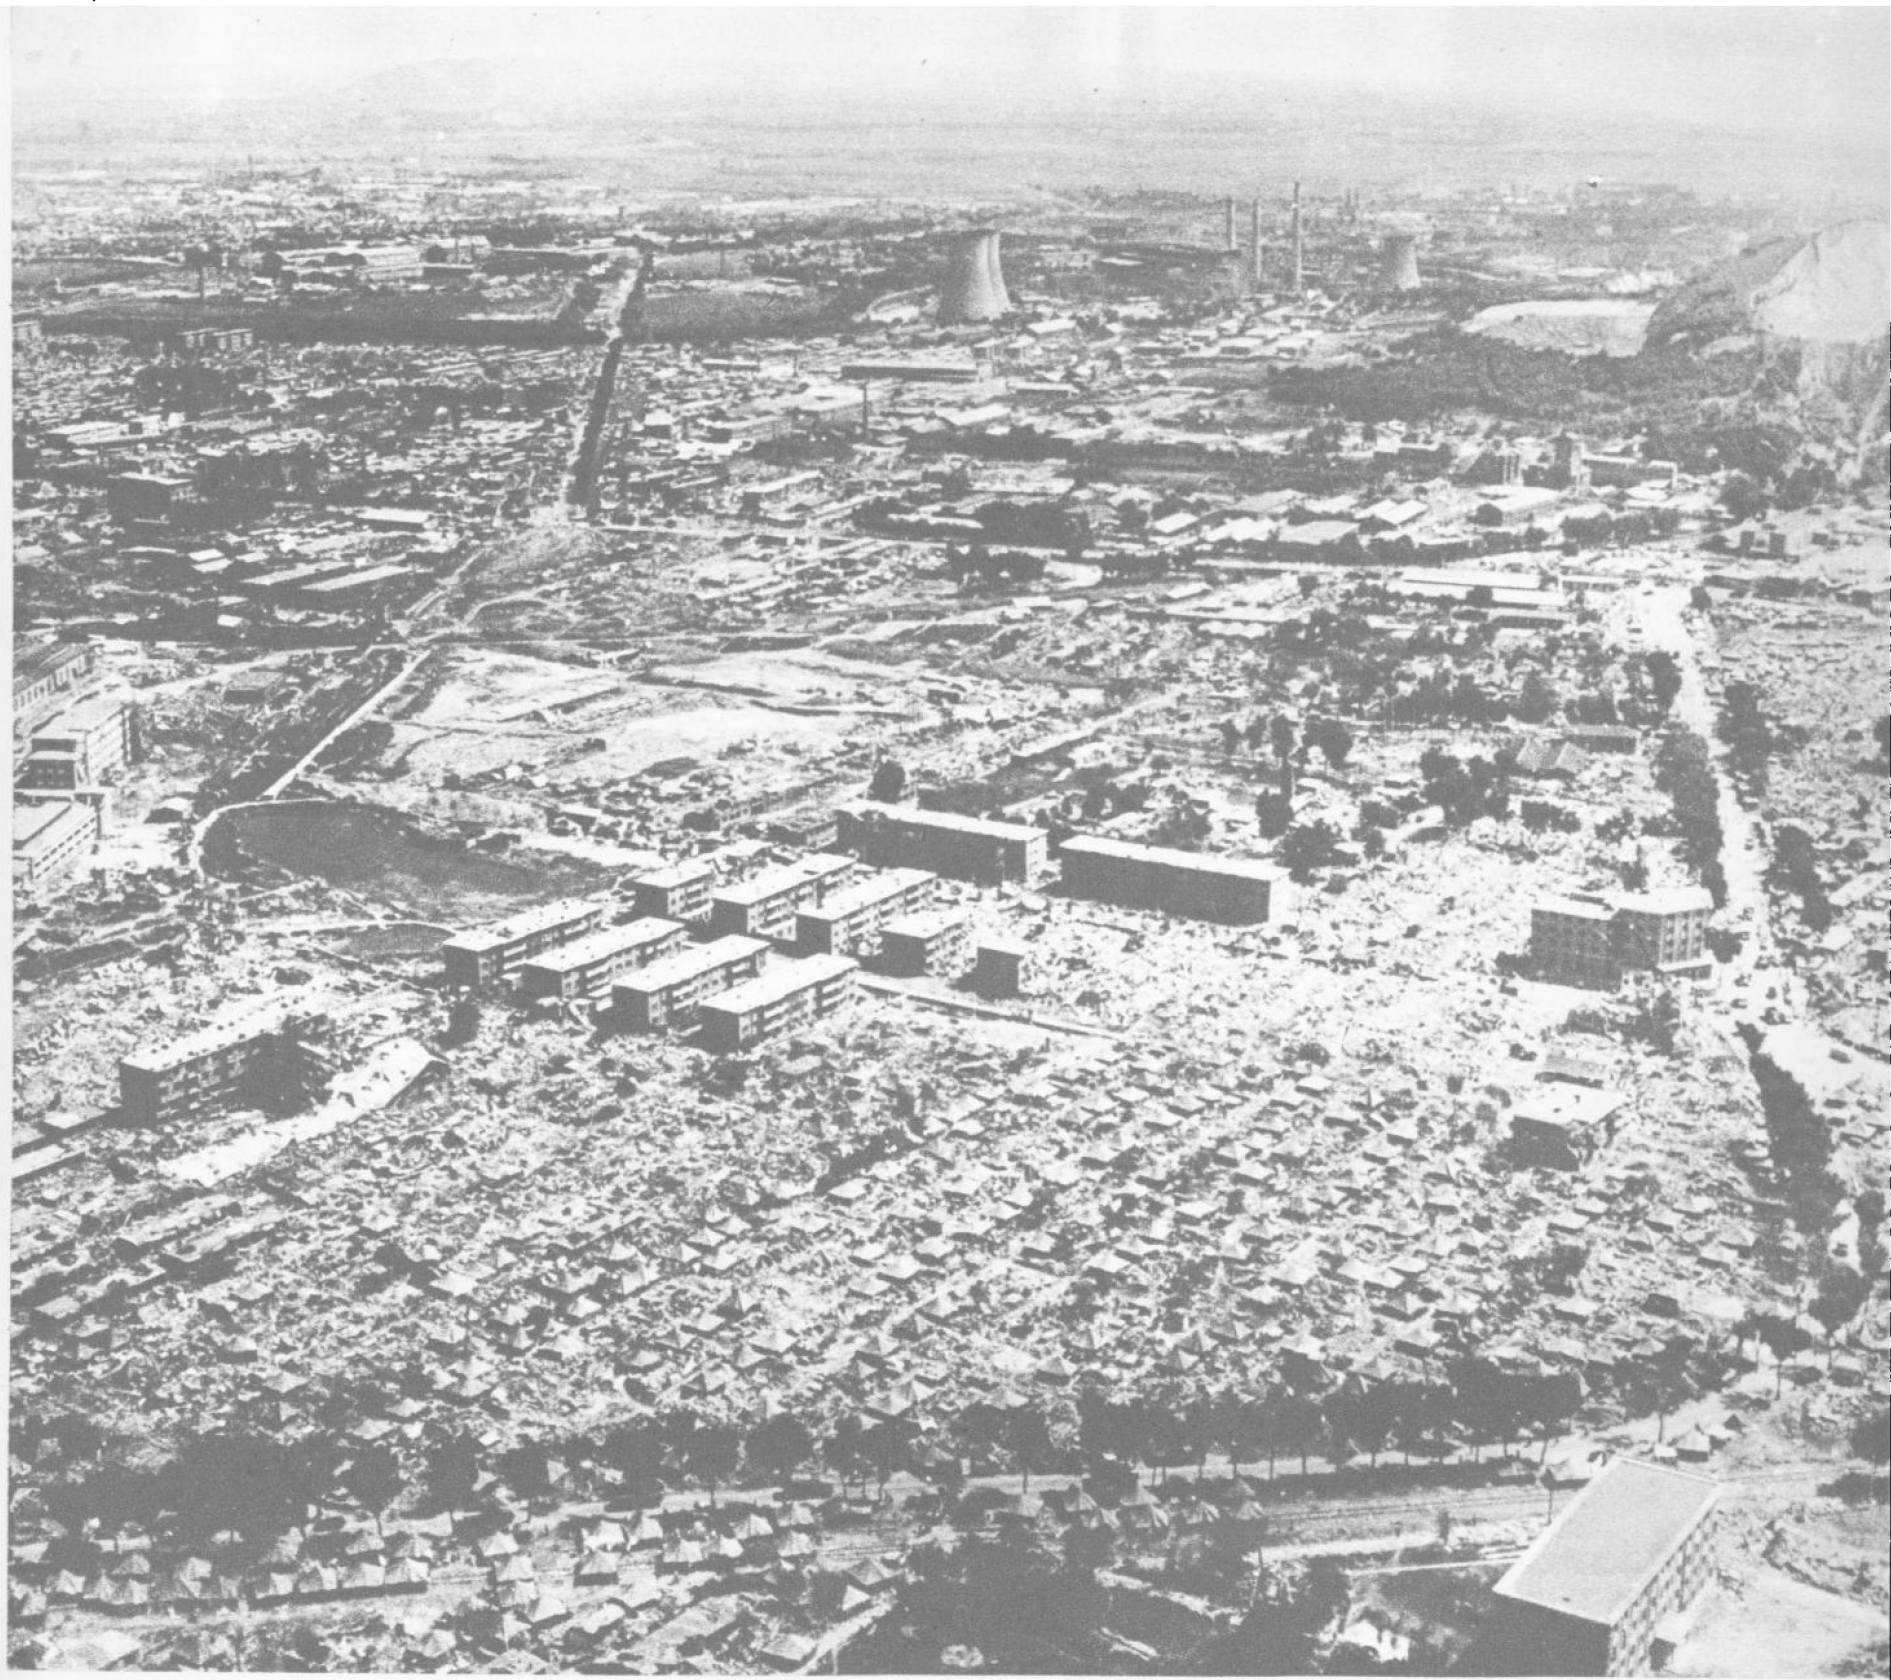
1—5 震后的唐山市路北区，绝大多数建筑塌毁，仅少数幸存（10度区）。

Most of the buildings were damaged with only a few left in the Lubei district of Tangshan after the earthquake (in the area of intensity 10).

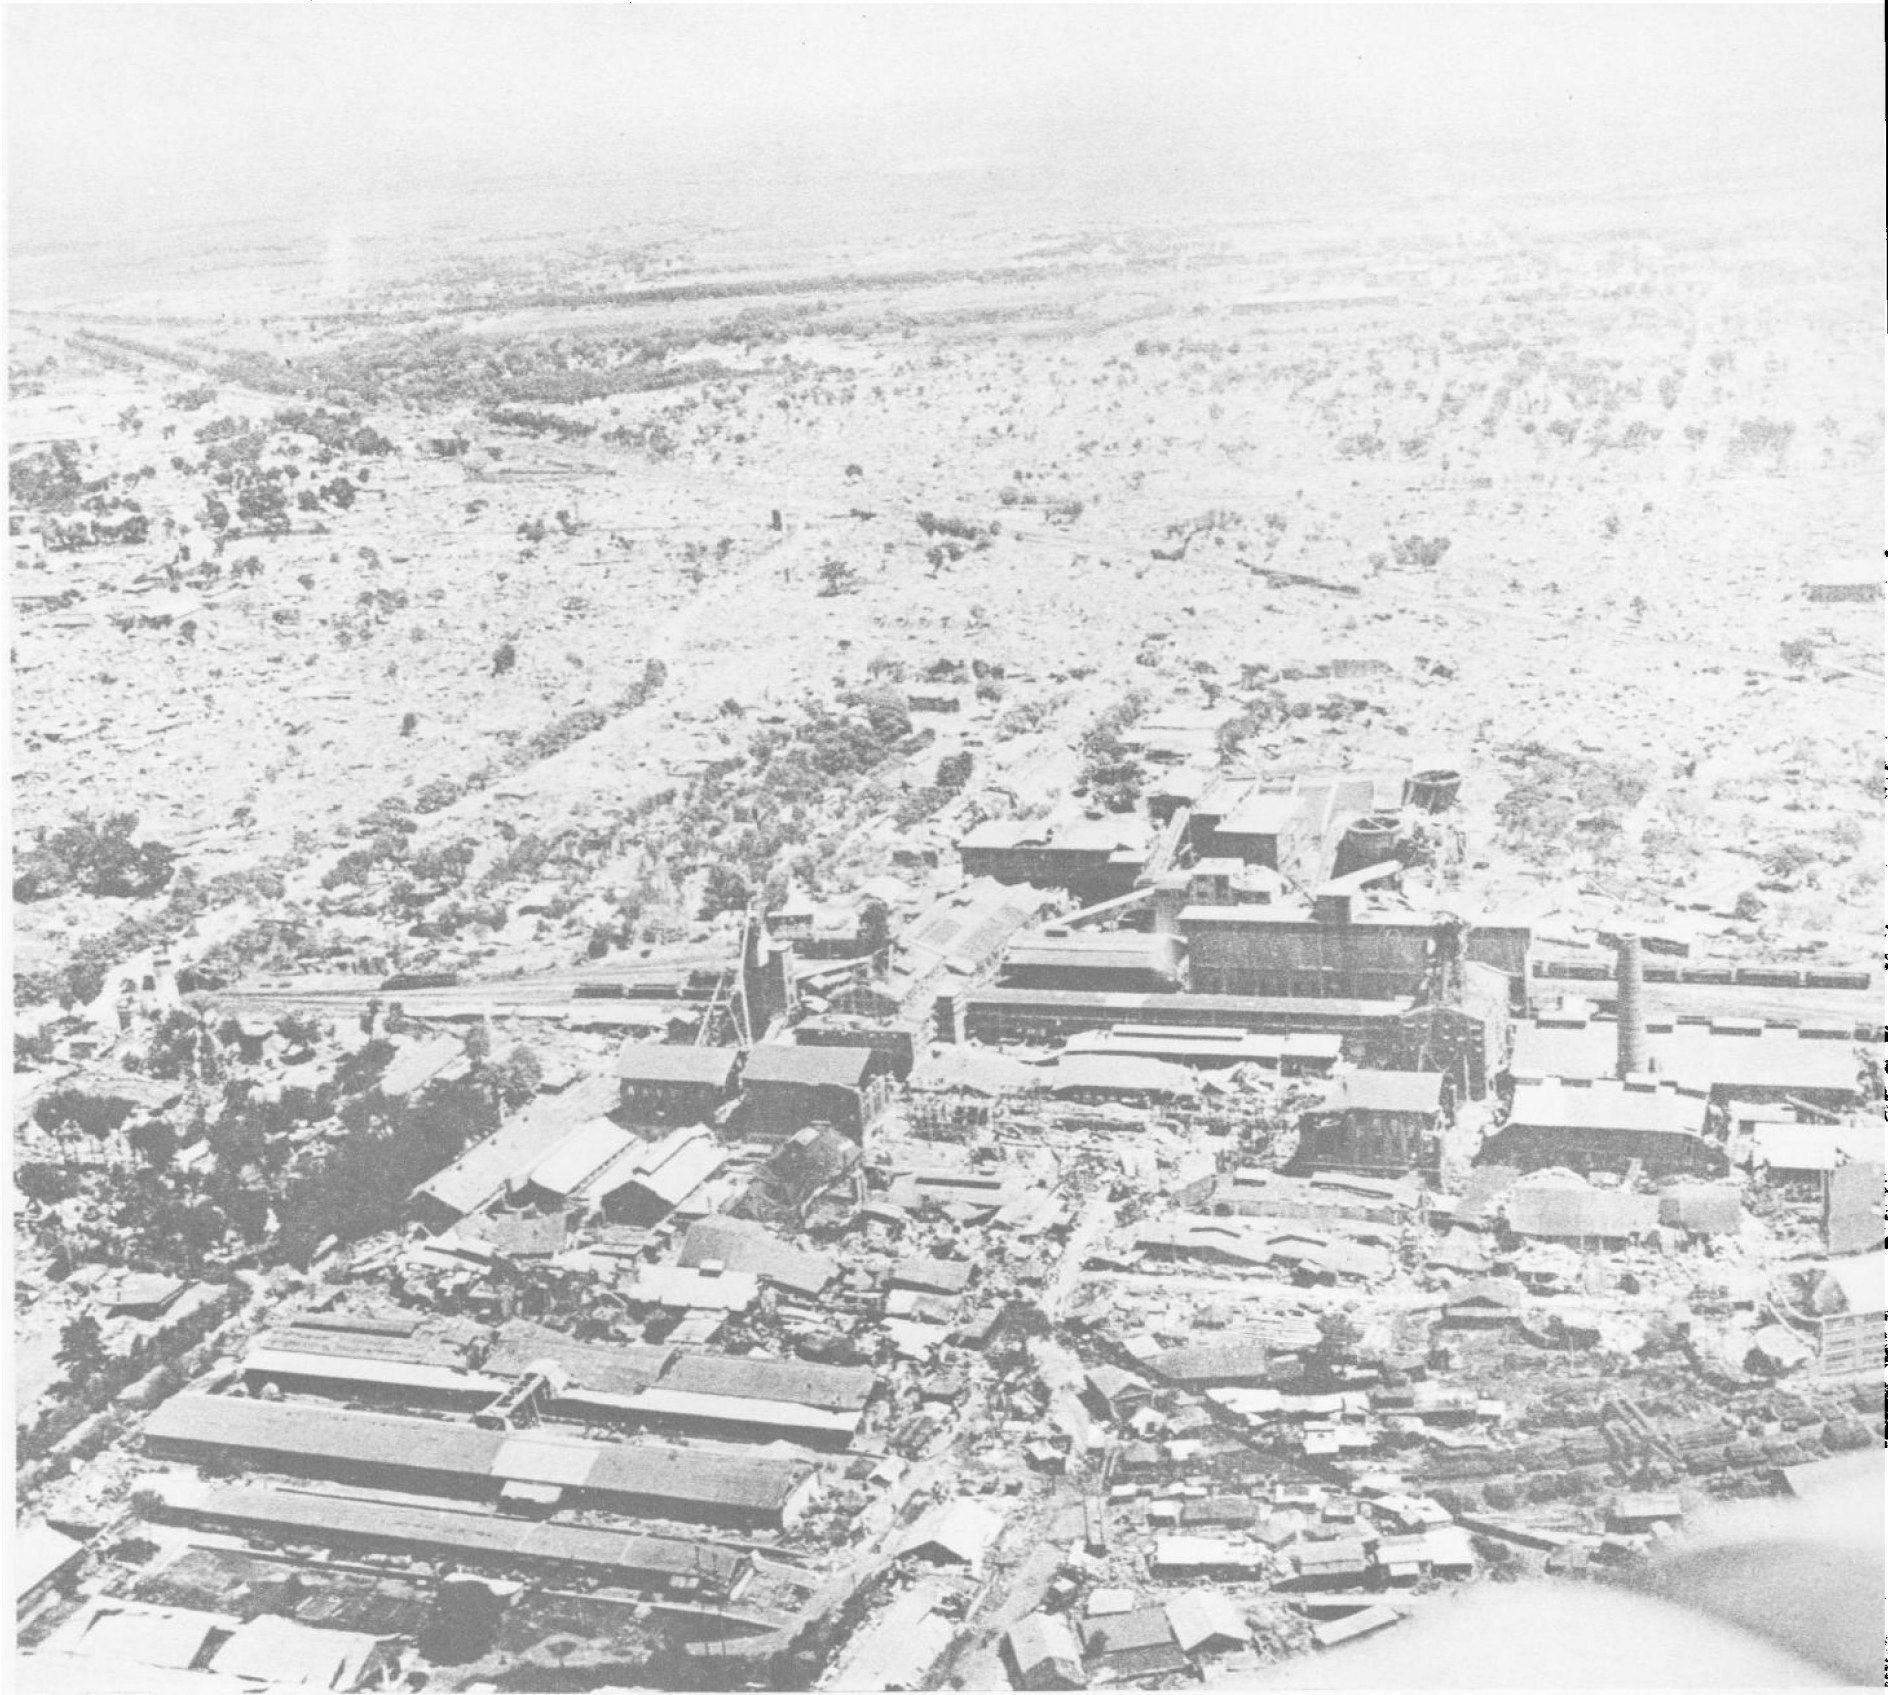
1—8 唐山市唐山开滦煤矿一带的建筑破坏情况（10、11度）。

Damage of buildings in the area of Kailuan coal mine in Tangshan (in the area of intensity 10 and 11).
