12th European Fluid Machinery Congress

A retrospective review of some troublesome turbine blade failures

H B Carrick

Process Industry Machinery Expertise Ltd (PrIME), UK

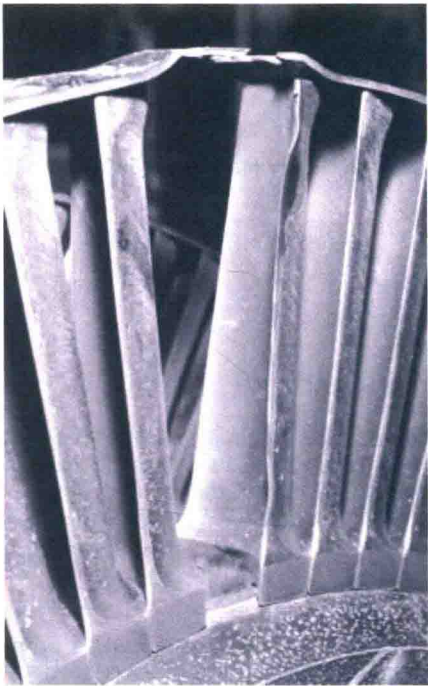
Figure 1

on the turbine at low speed so the turbine was opened. One blade was found to be missing from the last stage of this 4 stage turbine (see figure 1). It was concluded that the vibration following the blade failure had been so violent that it caused the turbine mechanical overspeed trip to operate.

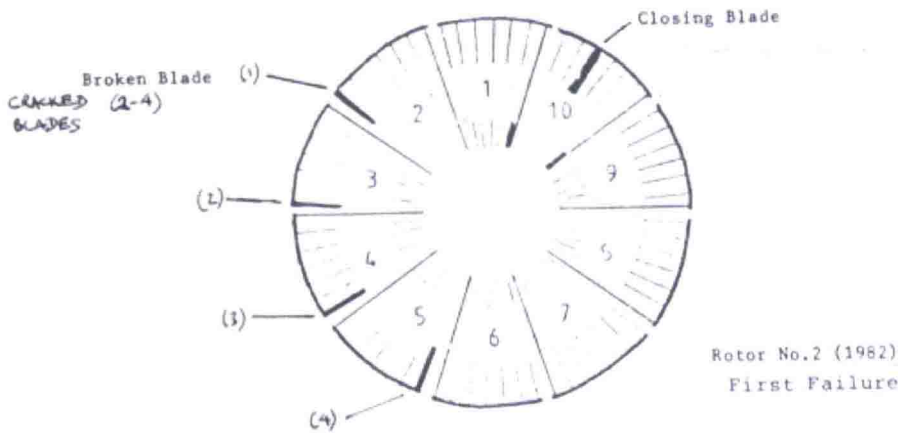
Figure 2

The blade fracture surface was dominantly fatigue. On disassembly another 3 blades in stage 4 were found to be cracked. The relative position of the cracked blades and the broken blade are shown in figure 2. The 70 blades were grouped into 10 packets (or groups) of 7 blades by a rivetted cover-band. It can be seen that the cracked blades were all at the end of a packet. Also the cover-band had interlocking 'tabs' at the ends of each packet, and these tabs had fretted, indicating relative motion between the blade packets. It seemed clear that the blade failure was due to blade packet vibration. Extensive investigations of blade, packet and disc natural frequencies were carried out by the owner.

This solution was not accepted technically or commercially by the owner, mainly because it was felt that the vendor was not investigating the failure seriously and because there was no guarantee available against a further failure. The turbine was re-bladed by a third party blade manufacturing specialist, supported by their consultant engineer. The blades were re-engineered with the following changes: improved material similar to that proposed by the turbine vendor, rolling radius for the root to eliminate corner loading, longer cover bands to damp out per rev excitation of the lower packet modes, better radial stacking of the blade profile and shot peened roots. The re-bladed 4th stage had four packets, two of 18 blades and two of 17 blades.

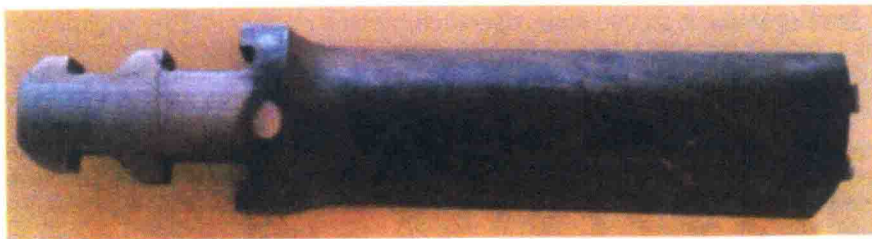
Figure 3

The blades had cracked at the upper platform of the double hammerhead root (see fig. 3).

The crack initiation was at the suction side corner. On further investigation it was found that the blade airfoil was stacked so that centrifugal loads imposed significantly higher stress on this side of the root. In addition, the blade root platforms were flat, while the disc groove is curved, hence all the centrifugal load was concentrated on the corners of the blades.

The failed blade was examined under the scanning electron microscope (SEM) by the vendor who concluded that the fracture surface indicated fatigue 'with the influence of corrosion'. Recommendations from the vendor included changing to a material of somewhat improved strength and corrosion resistance, re-stacking the blade profile to distribute the centrifugal load more equally, and increasing the radius between root and blade shank to reduce the stress concentration in the blade root.

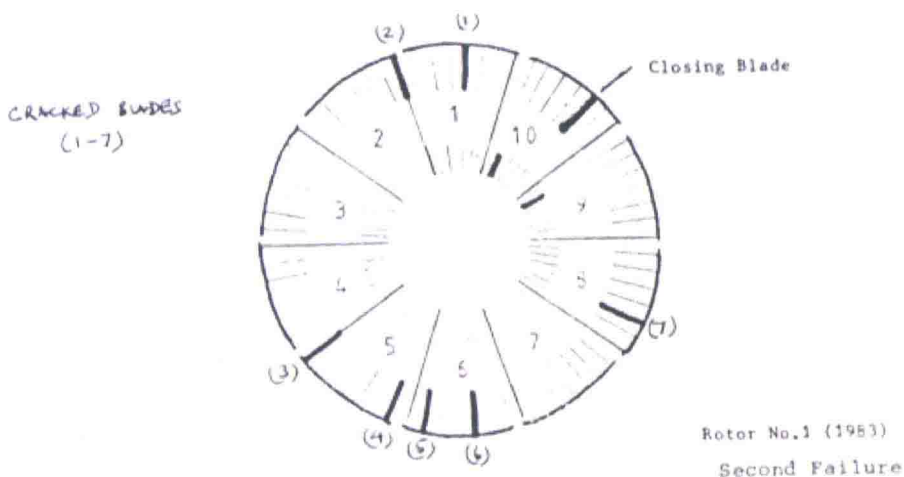
Figure 4

In 1983 after about 15,000 hours operation, turbine rotor no. 1 (the original spare) was removed from service and the 4th stage blades removed for examination. A number of blades were found to be cracked, but this time in different locations in the packets (see figure 4).

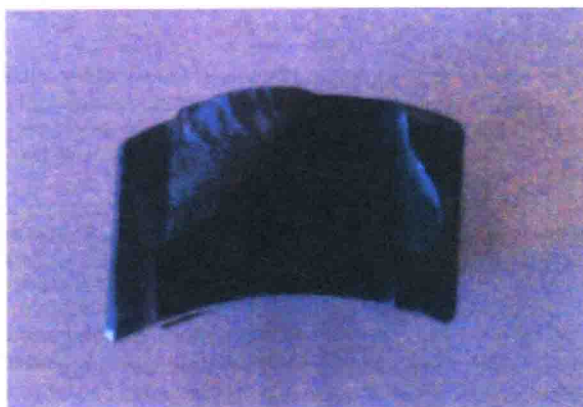
Figure 5

One of these cracks was over 75% through the critical root section of the blade (see figure 5). Once again the cracks were caused by fatigue. Obviously we had been very lucky to avoid another failure in service.
