FAILURE ANALYSIS

Case Histories and Methodology

Friedrich Karl Naumann

Max-Planck-Institut für Eisenforschung

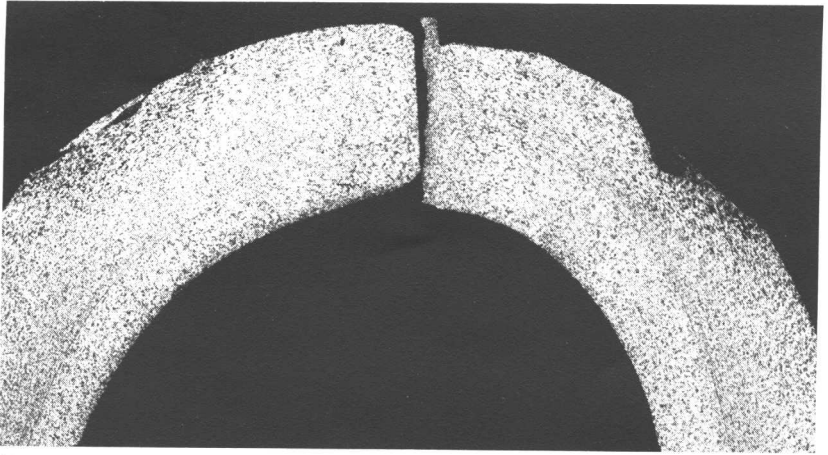
1.1

It was immediately apparent from the chain links that a welding error had occurred. Metallographic investigation served to confirm this. **Figure 1.1** shows a longitudinal section through the weld of a link. The weld seam was completely open. On either side of the joint zone, craters were visible. Apparently these were current contact points. From the fine structure (**Fig. 1.2**) it can be seen that the steel had elongated grains at the joint. This confirms that this part was not heated to a high enough temperature, whereas high resistance at the current entry points heated these areas to partial fusion and apparently hardened them in spots. In this case the material was erroneously thought to be at fault. Any answer to the original question, even if such were possible, would not have been of any help to the manufacturer. But the findings now made it possible for him to remedy the situation.

Fig. 1.1. Overview 10 \times . Overheated and molten spots from current entry at both sides of non-bonded weld

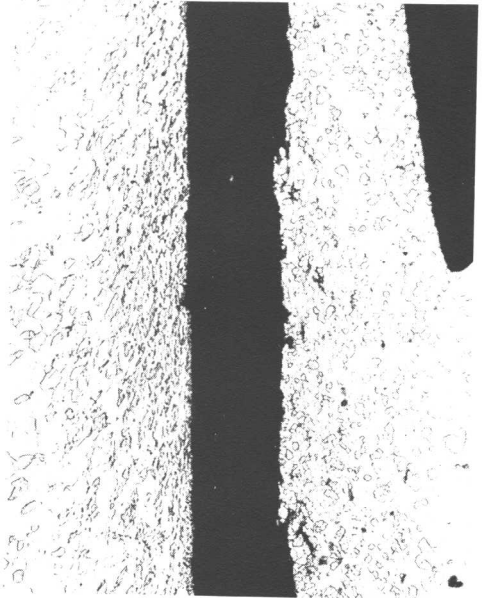
1.2

Fig. 1.2. Elongated grain structure through cold deformation at welded joint. 100 \times

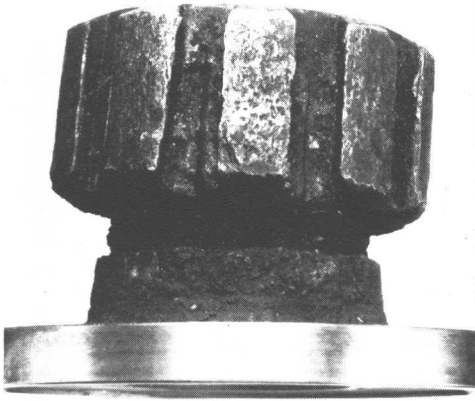
The principal cause of failure in this case was the improper thread engagement which caused high stress in the ring, bushing, and especially the thread. This failure, like the preceding one, could be explained by mere visual inspection of the parts. Analysis served solely to confirm that the right material was selected.

Fig. 1.3 to 1.5. Ring from safety valve of seagoing vessel destroyed by stress corrosion

Fig. 1.3. External view. 0.7 ×

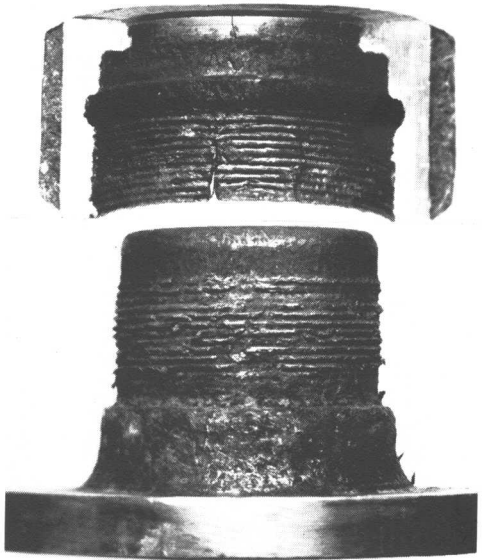
1.4

Fig. 1.4. Internal view after cutting open of the ring. 0.7 ×

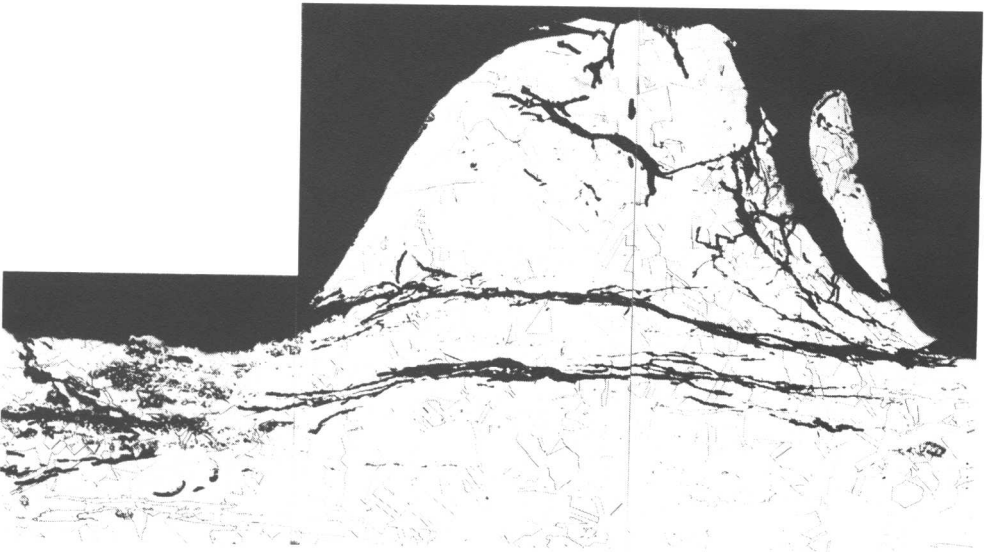
1.5

Fig. 1.5. Longitudinal section through thread of bushing.
Etch: V2A-etchant*. 85 ×

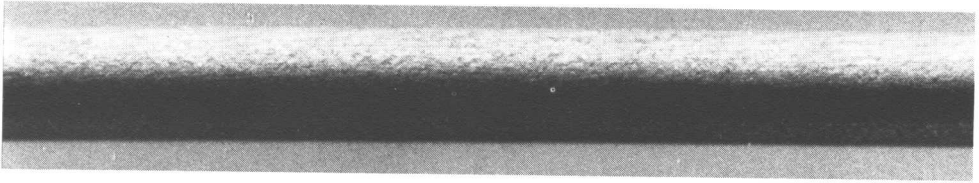
1.6

Fig. 1.6. Smooth area

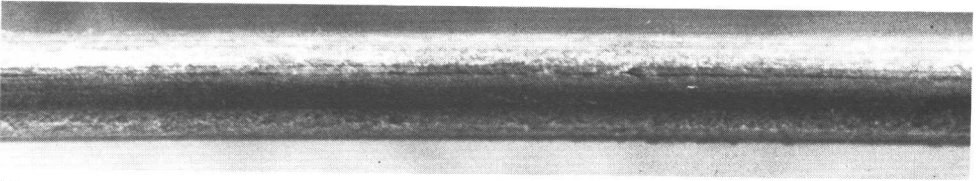
1.7

Regardless of the type of steel, heat to heat variation, or dimensions, surface defects of various kinds could be determined in those spots displaying poor klanken tear behavior, while the satisfactory sections were smooth (Fig. 1.6). Failures were mostly initiated in longitudinal grooves (Fig. 1.7) where the wires sometimes developed cracks during drawing (Fig. 1.8).

Fig. 1.7. Spot with groove

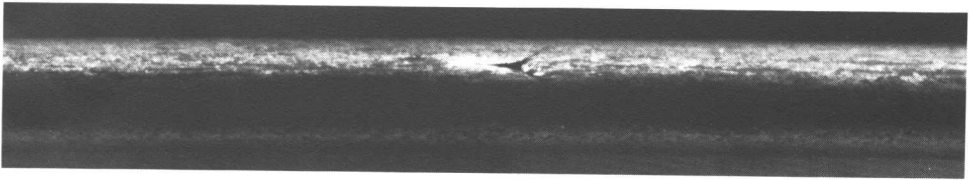
1.8

Fig. 1.8. Spot with incipient crack

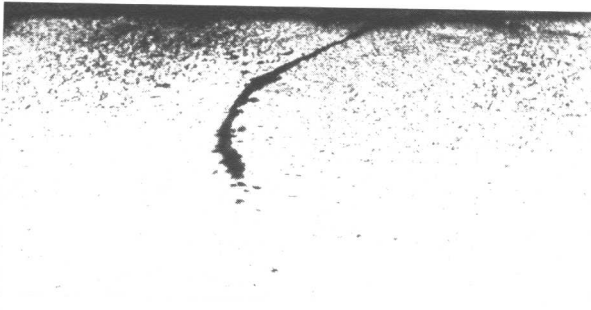
1.12

Fig. 1.12. Tensile crack at spot carburized by drawing lubricant. Etch: V2A-etchant. 200 ×

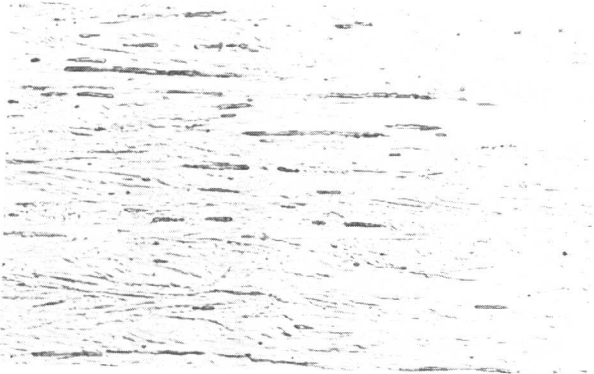
1.13

Fig. 1.13. Grain structure in longitudinal section. Etch: V2A-etchant. 500 ×

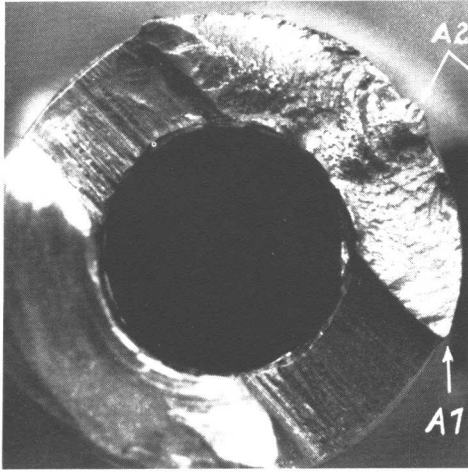
1.16

A **bone drill** of stainless tool steel¹⁾ fractured during drilling of the marrow cavity in the leg of a patient which should be splinted subsequently by driving a pin through the fracture. The fracture propagated from a fatigue crack shown in **Fig. 1.16** and is designated with A2. At the fracture origin, the remains of a number could be seen (**Fig. 1.17**) which had been inscribed with an electrical engraving tool. The larger part of this number was on the unavailable opposite fractured part. The cross section of the drill was weakened at this point by a milled groove from whose edge another fatigue fracture propagated (A1). A longitudinal section through A2 showed that the material had melted and hardened during cooling. It also showed several incipient cracks (**Fig. 1.18**). This crack initiation led to the formation of the fatigue fracture. Any damage to the surface should be meticulously avoided, especially in specimens which are cyclically stressed.

Fig. 1.16. and 1.17. Views 10 ×. Fatigue fracture propagated from A1 and A2

Fig. 1.16. Fracture plane

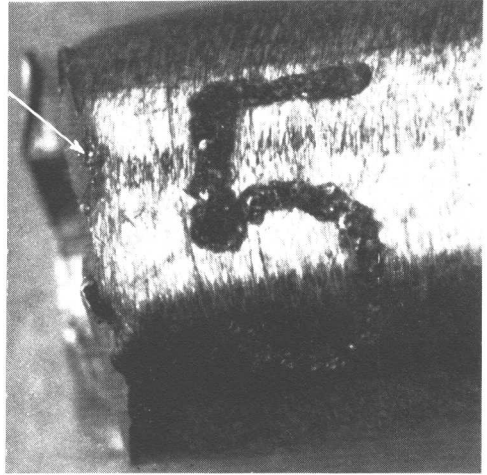
1.17

Fig. 1.17. Surface at fracture

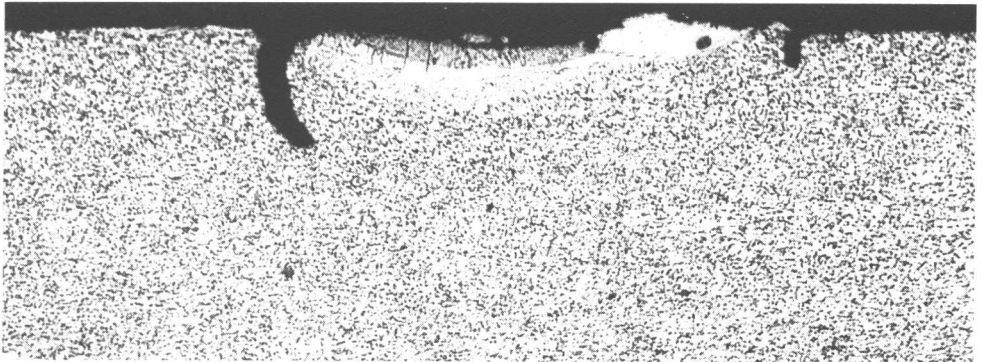
1.18

Fig. 1.18. Microstructure at fracture origin A2. Longitudinal section. Etch: V2A-etching solution. 250 ×

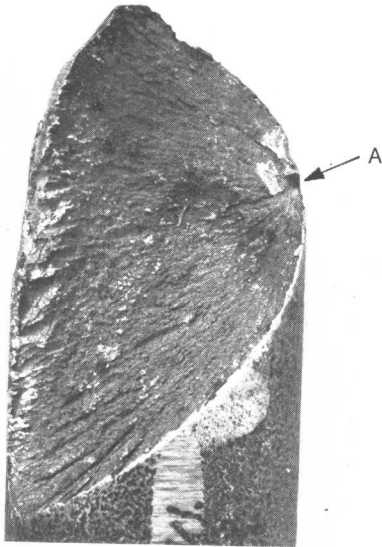
high stresses concentrate (compare with section 2.1). Chemical and metallographic tests showed that steel quality and heat treatment were satisfactory. But the martensitic structure indicated that the tempering temperature was fairly low. In consideration of this fact, the hardness which ranged from 572 to 606 HV 10 was extremely high. The high hardness, although not damaging to a smooth surface, here prevented stress relief by deformation in the grinding grooves. The fracture therefore was caused by grinding grooves and the high notch sensitivity of the hard material.

Fig. 1.19 and 1.20. Rear axle side shaft with torsion fracture originating at grinding mark (A). 1 ×

Fig. 1.19. Fracture

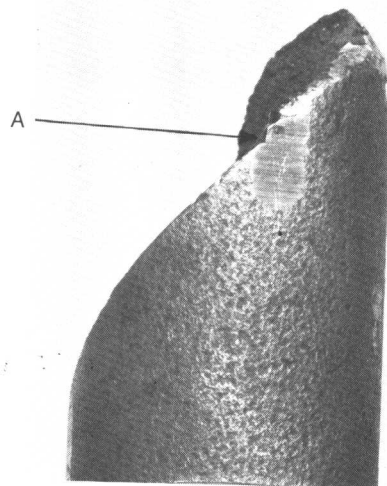
1.20

A **rear-axle side shaft** of a truck broke during driving. It was said to consist of chromium-molybdenum alloy steel of AISI type 4140 and heat treated to 460 to 515 HB. The automotive manufacturer wished to find out if quality and heat treatment corresponded to standards. The fracture of the shaft was of a torsional nature that propagated from a small fatigue crack (**Fig. 1.19**). It originated in grinding grooves which in turn were caused by the grinding of a flat plane for a Brinell hardness test (**Fig. 1.20**). Such grinding grooves are deep notches at whose bottoms

Fig. 1.20. Surface at fracture origin
