汶川地震地质灾害

WENCHUAN EARTHQUAKE
GEOHAZARDS

Key Laboratory of Engineering Geomechanics, CAS

伍法权 胡瑞林 岳中琦 等著

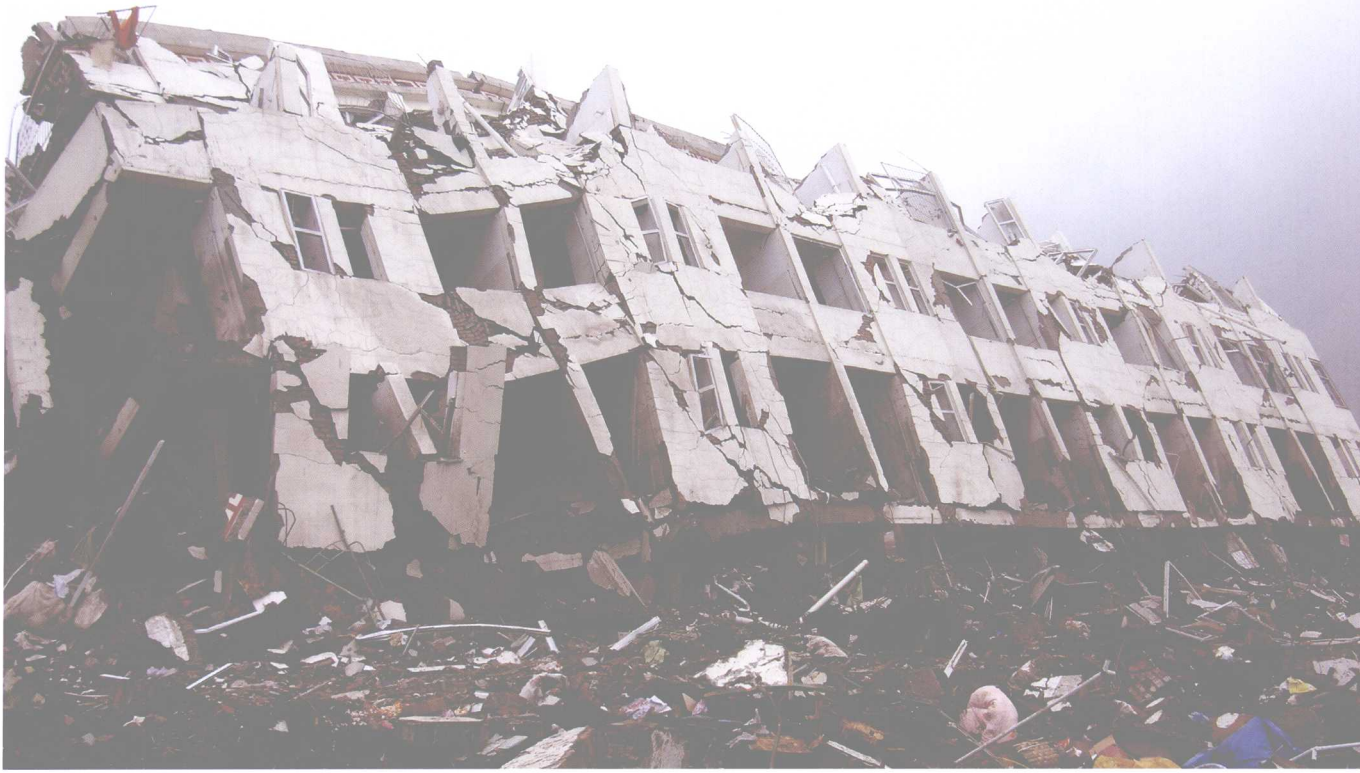
映秀镇漩口中学楼房倒塌
Ruined buiding of Xuankou High School in
Yinxu Town

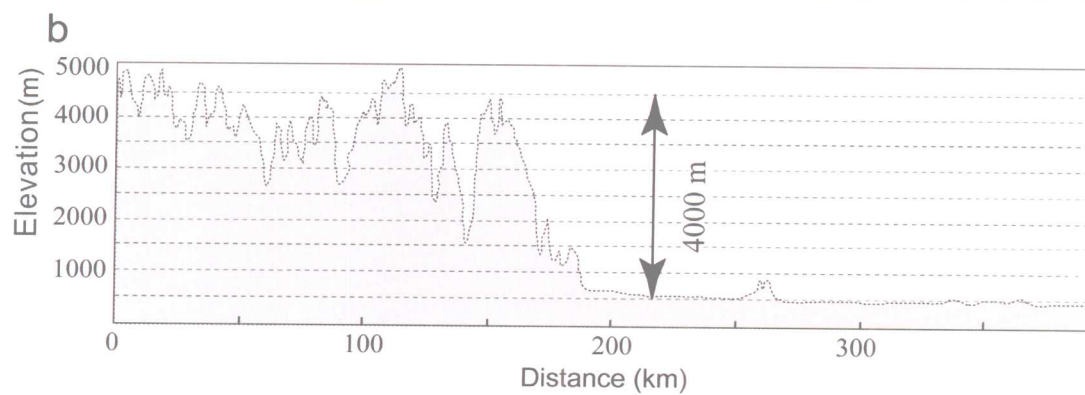
龙门山地震断裂带是青藏高原周边地形梯度变化最强烈的地区，在50km范围内从四川盆地平均海拔600m左右，迅速变为5000m左右的高原，地形高差达4400m。

The Longmen Shan earthquake fault zone is the edge region of Tibetan Plateau with the highest changes in land topographical gradients. The altitude at its foreland in Sichuan basin is 600 m and increases to 5000 m on the Plateau over a horizontal distance of 50 km. The altitude difference is 4400 m.

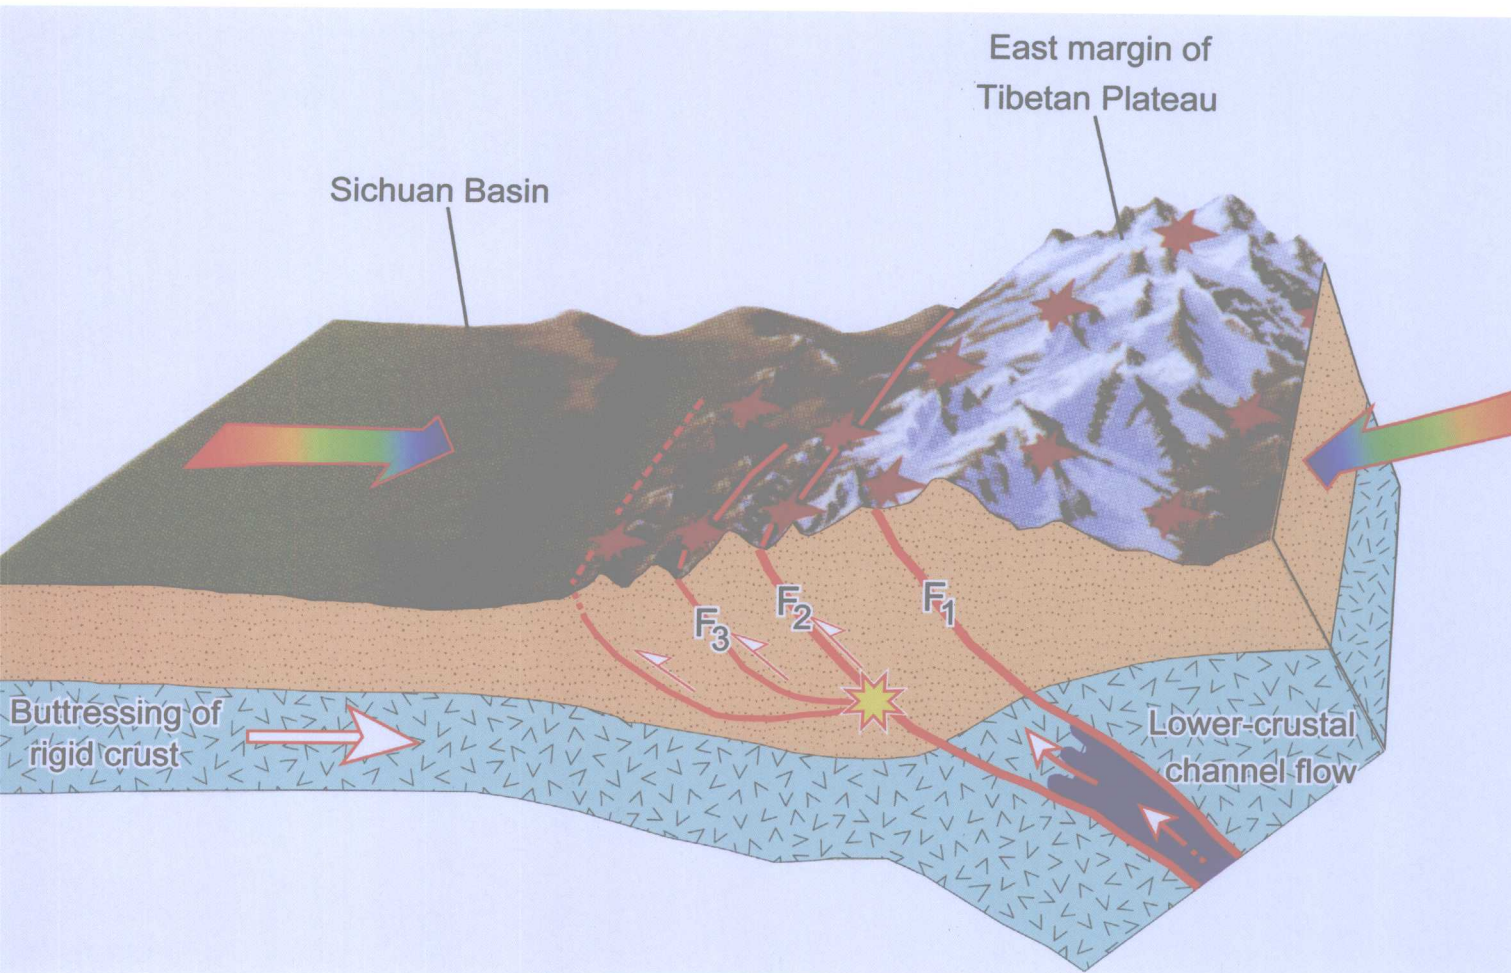
汶川地震发震的地球动力学机制模型
Geodynamic mechanism model for focal
mechanism of Wenchuan Earthquake

龙门山地震断裂带的构造变形十分强烈,其新生代隆升可能与青藏高原的下地壳流引起的向东挤出与四川盆地坚硬结晶基底的阻挡之间的相互作用有关,此次大地震的发生很可能是下地壳流向东挤出所产生长期应力积累释放的结果。

Structural deformation of the Longmen Shan earthquake fault zone is very strong. The uplift of the zone in Cenozoic may be due to the interaction between the eastern extrusion induced by the lower-crustal channel flow beneath Tibetan Plateau and the buttressing of the rigid crust of Sichuan basin. The occurrence of this Earthquake may be a result of the release of the long-time stress accumulation caused by the eastern extrusion of the lower-crustal channel flow.

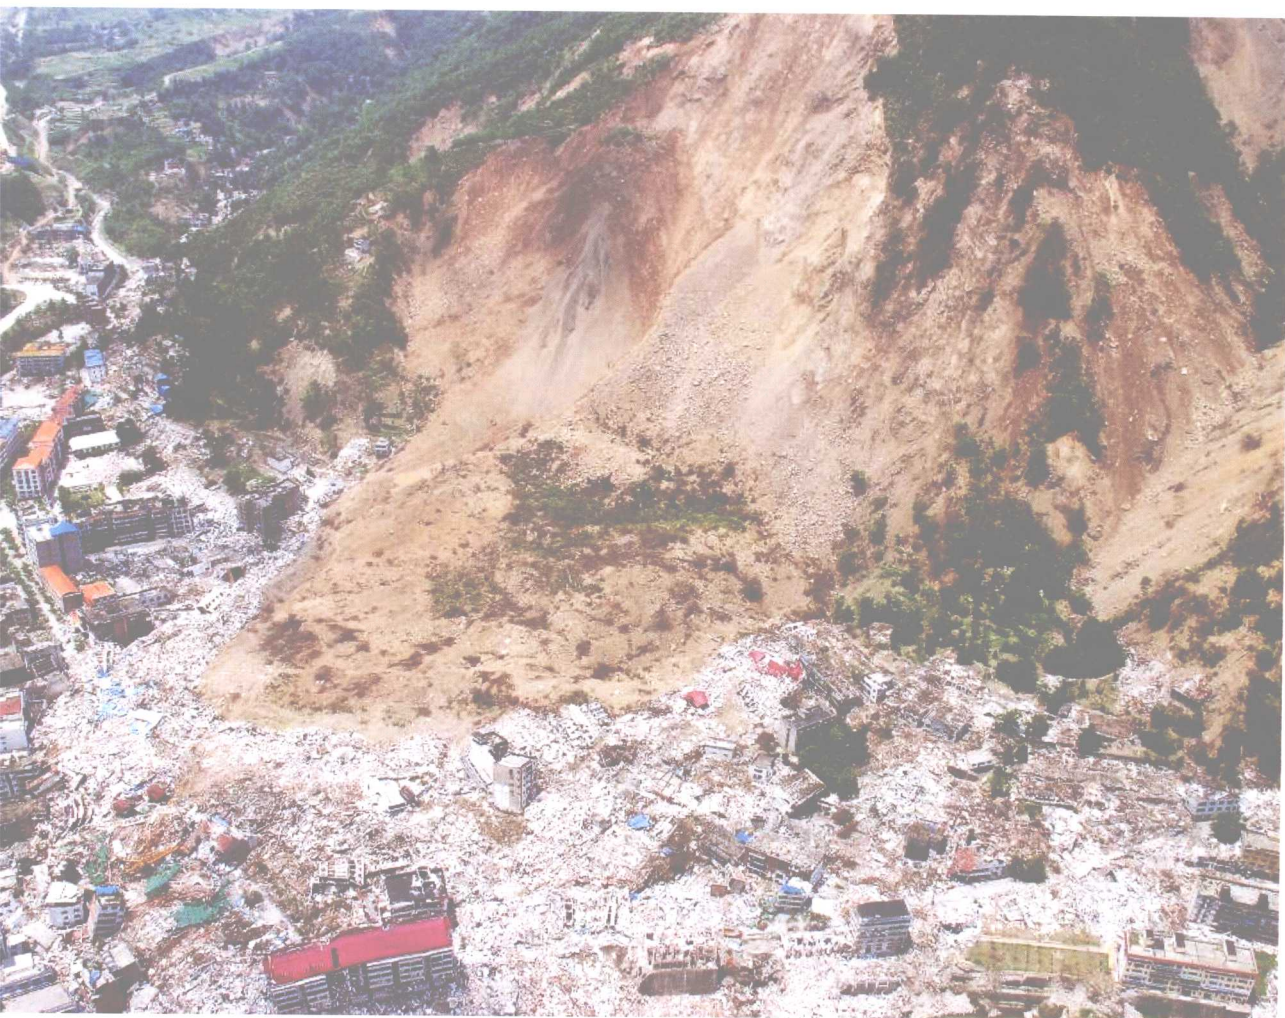
北川县王家岩滑坡是北川旧城变为废墟的主要原因,直接掩埋 1600 人 (李晓摄)
The Wangjiayan landslide is the main cause that ruined Beichuan old town and buried 1600 people

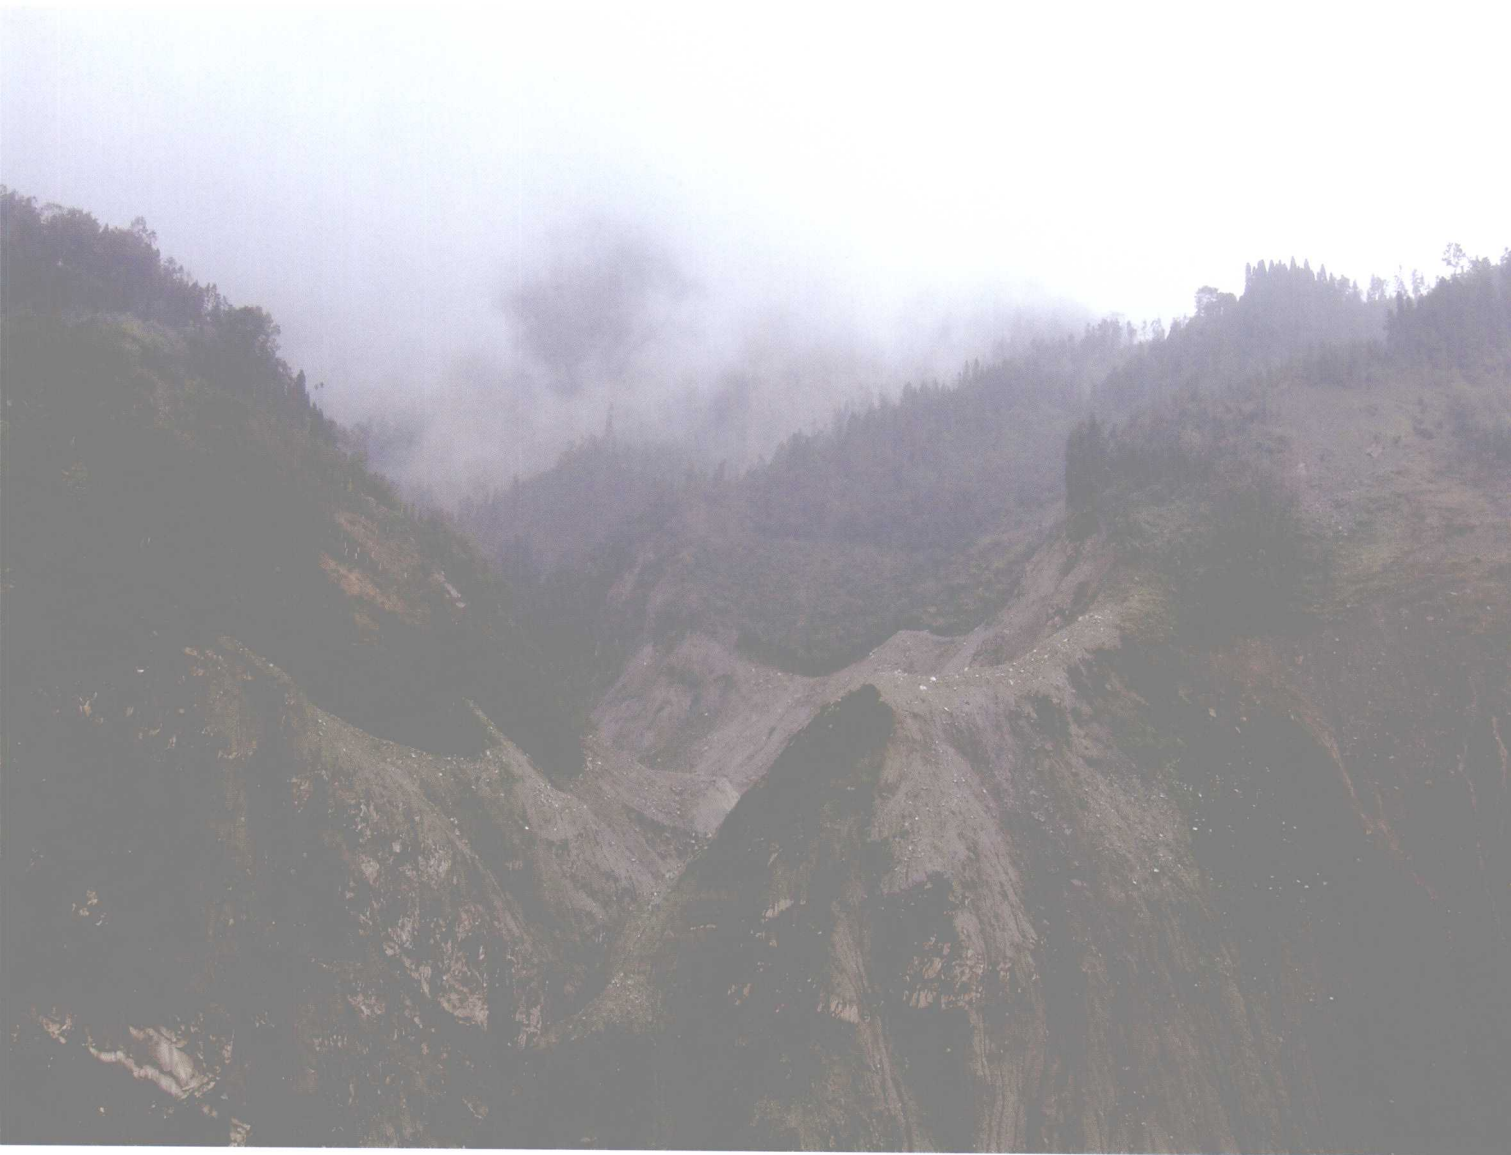
映秀牛圈沟高速远程滑坡 – 碎屑流滑坡
A high-speed and long-distance landslide
and debris flow landslide at Niujuangou
near Yingxiu town

在本次地震过程中，高速远程滑坡是一种危害最为严重、比较常见的类型。此类滑坡多以高位崩塌为主，受地震动力抛射作用和地形坡降的控制，以高速碎屑流形式，经历了高位崩滑—低空飞行—远程抛洒—气垫冲击等演变过程。比较著名的高速远程滑坡有青川东河口滑坡、平武南坝镇新平村滑坡群、映秀牛圈沟滑坡、北川县城王家岩滑坡等。

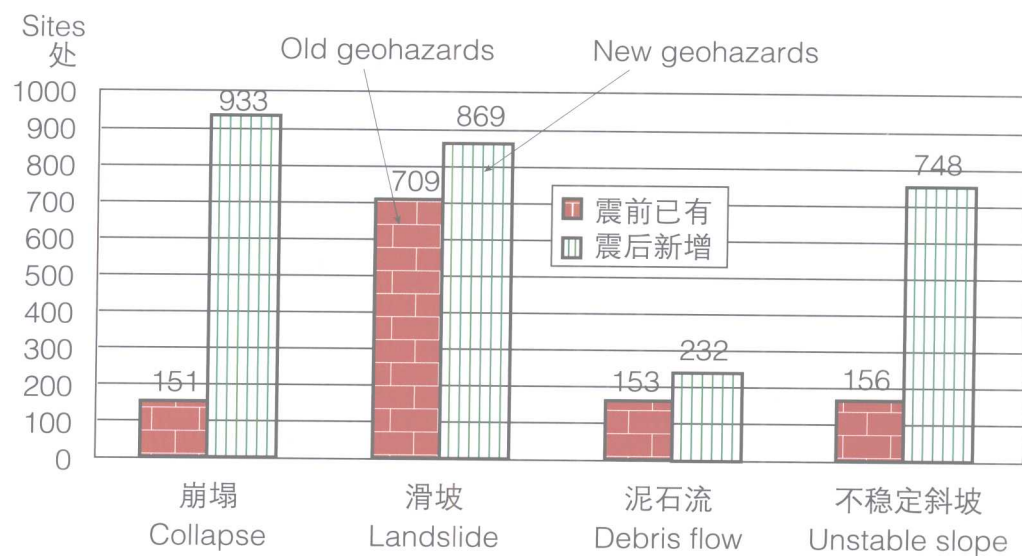
图1 极重灾区地震前后地质灾害隐患比例(据殷跃平,2008)
Fig.1 Statistics of the potential geohazard sites in the epicenter zones before and after the Earthquake

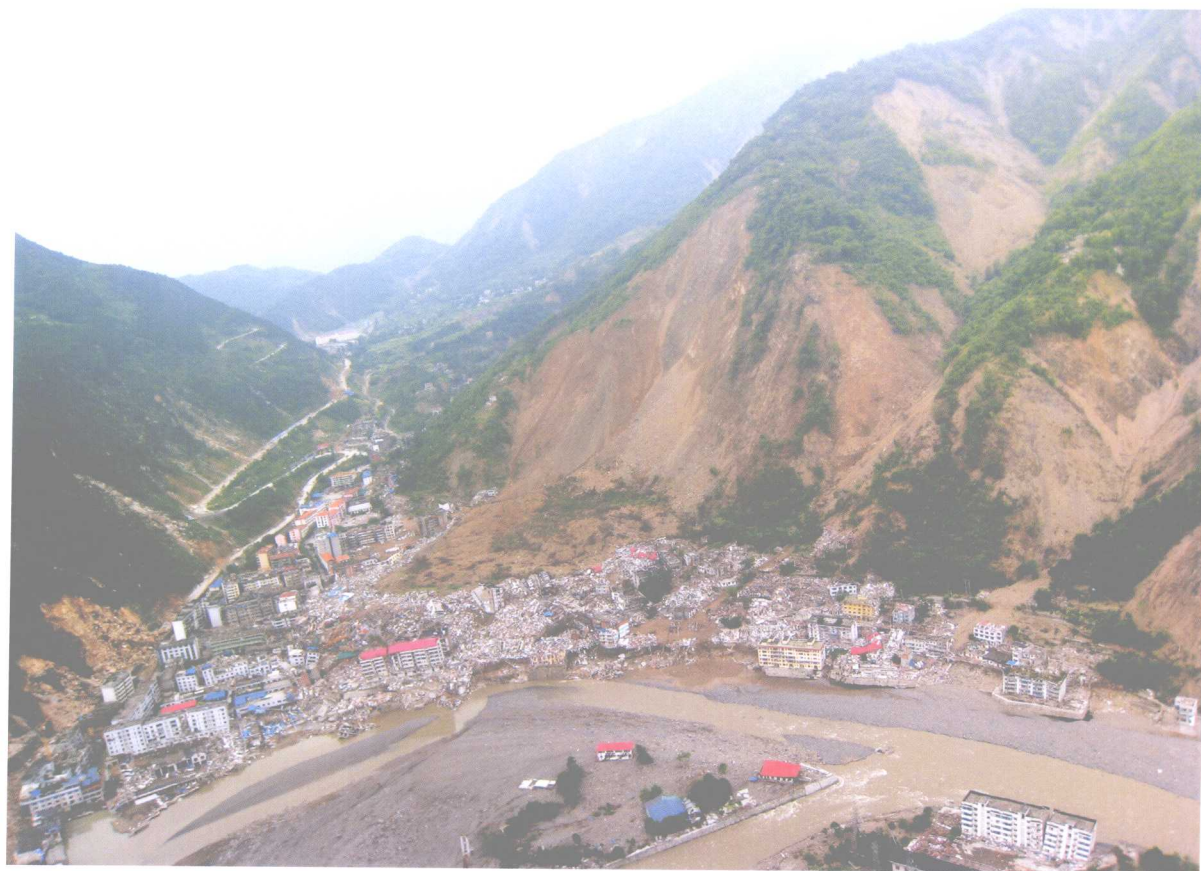
北川县老城王家岩山体滑坡 (李晓摄)
The Wangjiayan landslide in old Beichuan town

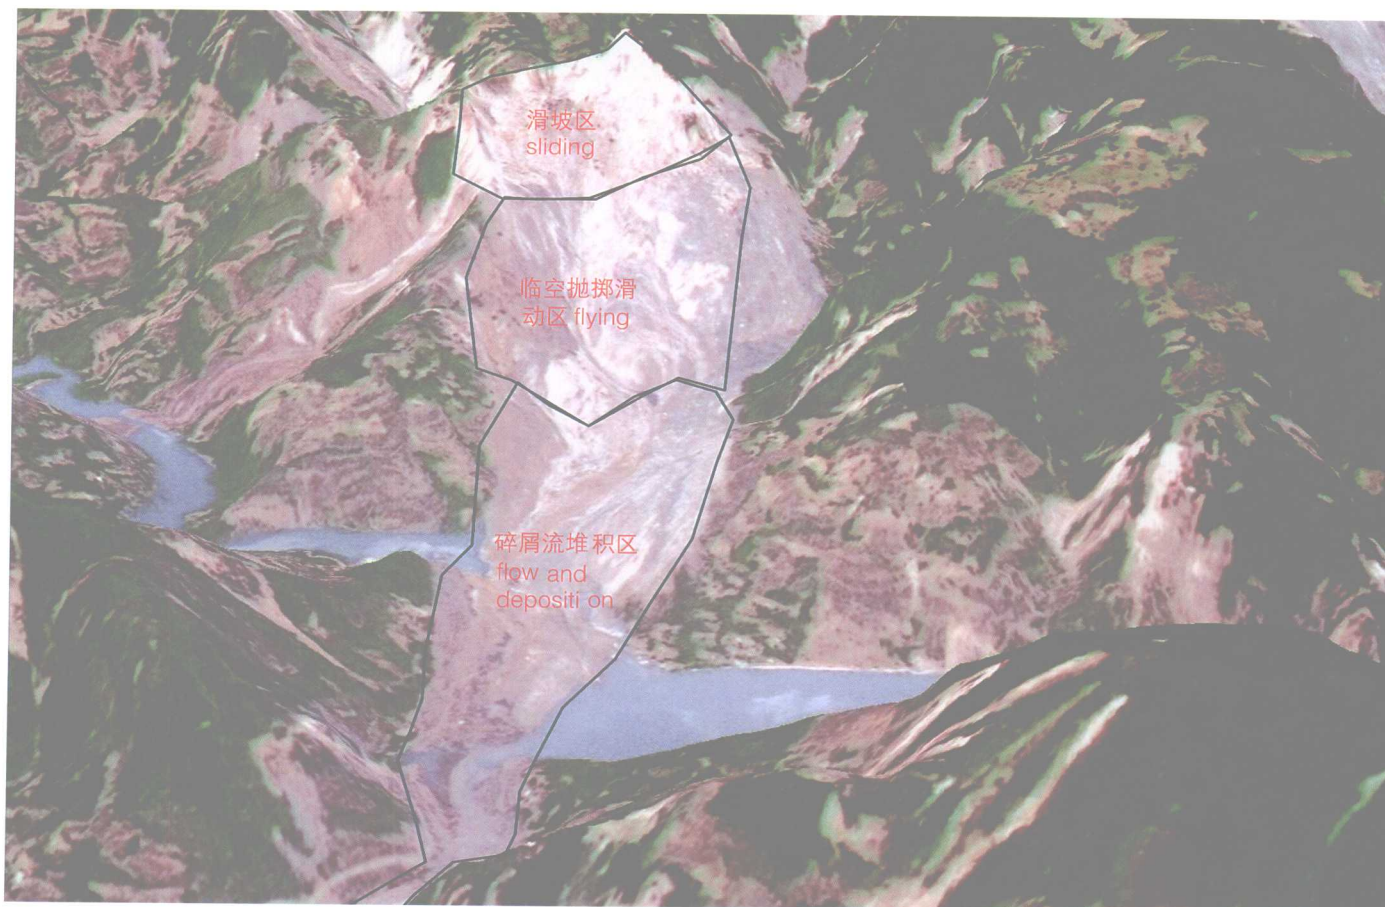
抛射型高速远程滑坡——青川东河口滑坡 (宽 200 ~ 600m, 长 2500m, 面积 1.09km², 体积 1250 万 m³, 掩埋 260 人, 据许强)
The high-speed and long-distance landslide —— Donghekou landslide in Qingchuan (200 ~ 600 m wide, 2500 m long, the area 1.09 km² and the volume 12.5 million m³, buried 260 people, after Qiang XU)

During the earthquake, the high-speed and long-distance landslides were the most serious and relatively common type. They were formed from the collapses at high positions and then transformed to high-speed debris flow under the control of kinetic energy from both the ground shocking and altitude reduction. The process of high speed debris flows experienced collapses at high positions, low attitude flying, long-distance scattering and air-cushion impact. Some well-visited landslides of this type are Donghekou landslide in Qingchuan, landslide group at Xinping village of Nanba Town in Pingwu county, Niujuangou landslide in Yingxiu town as well as the Wangjiayan landslide at Beichuan town.
