WELDING OF CASTINGS

**An international conference arranged by The Welding Institute,
The Steel Castings Research and Trade Association,
and the BNF Metals Technology Centre**

Maintenance and repair welding of castings

By C. Cookson, FWeldI, LIM, AMIET

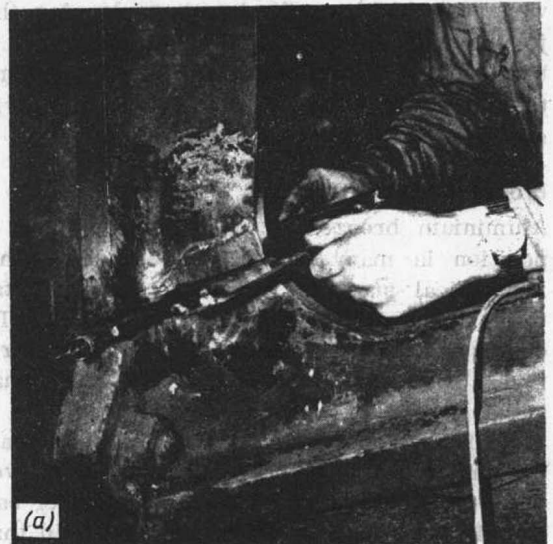
2 Osney Bridge showing: (a) cracks, dye penetrant tested, (b) cutting with hacksaw, and (c) nickel strip in place

All the members of the bridge were ground and dye penetrant tested, Fig. 2a. A 6mm diameter hole was then drilled at the termination of each crack which was afterwards cut through with a hacksaw, Fig. 2b. The cracks were ground out U fashion, one-third from each side, and a nickel strip inserted. The insertion of the nickel strip was a new technique devised by the author, Fig. 2c.

The technique of inserting the nickel-iron strip into the hacksaw cut through the crack may be summed up as:

- 1 The hacksaw cut removes any rust and impurities which may cause outgassing

during welding, with subsequent disruption of the welding arc.

- 2 The metallurgical notch effect at the root is possibly minimised.
- 3 Practical tests and metallurgical examination of typical sections showed clearly that the weld metal on the initial weld beads on the outside of the joint was allowed to contract by the closing of the joint faces into the annealed nickel strip.
- 4 Although no significant additional strength would be achieved in the joint by welding each side into the nickel strip, the neatness of the joint and other attendant advantages can be appreciated.

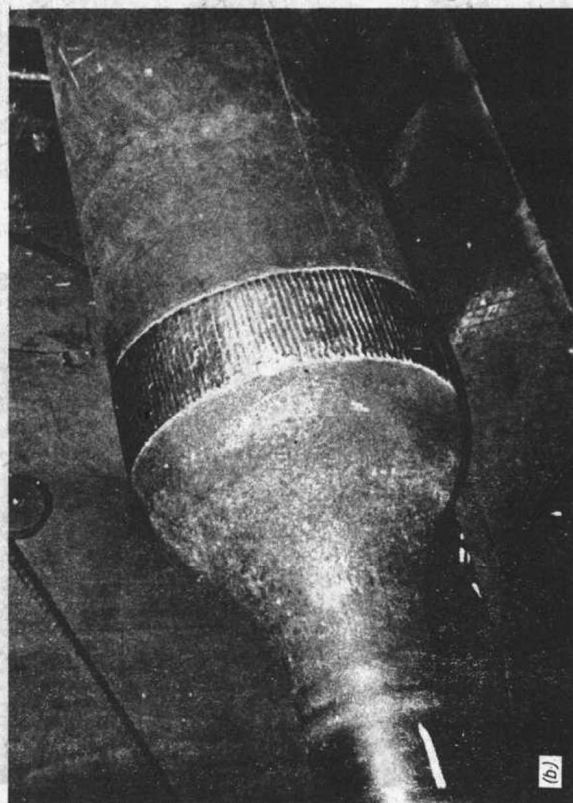
5 Furnace roll showing: (a) clad faces and bars in position, (b) completed roll

The root deposit was completed next, using the back-step technique with air quenching and comprehensive peening. It was decided to incorporate 19mm round bar sections in the repair in a 'Jacob's Ladder' formation to reduce the amount of weld metal required by 6kg and thus the overall strain, Fig. 5a.

The joint was filled in the next stage using a block sequence with 5mm diameter electrodes, and was finished in the inter-block areas after the entire circumference had been covered to reduce the degree of stress in the joint. A final capping layer was deposited without peening, Fig. 5b.

To minimise the reaction stress the entire joint area was clad, using a 'soft arc' coating 25/20 Cr-Ni type metal-arc deposit. A 3.2mm diameter electrode was employed to limit the region of contraction strain, before peening of the deposit reversed this stress to a compressive one to the base metal.

AISI Type 304 bars were the only bar material available and although it is inferior to the furnace roll material, it was adopted because it would be well below the surface layers. The bars were raised and tacked at each end to allow complete root penetration from both sides, still using a 3.2mm diameter electrode. The bars were then dressed down with a hammer, having previously been bent to the required shape to produce a consistent root gap. The repair proceeded using the same technique of depositing short runs, immediately peening with a simultaneous quench, using an air line with a jet forced as high as could be tolerated.

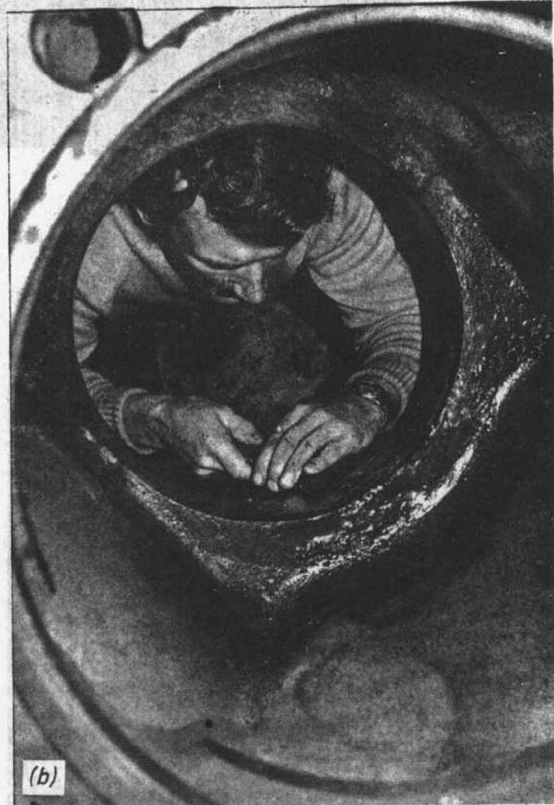
9 (a) completed repair, (b) scraping in operation

The two bars (12.7mm diameter) were of En 110. These were initially clad with the TIG process and a nickel wire containing titanium (employing a 250°C-300°C preheat) to allow the relatively cold welding of the bars to the casting at a later time, and so avoid HAZ cracking in the bars. Figure 9a shows the completed repair with one bar visible.

The final stage of the repair was the tinning of the inside face of the broken section, using a tin-based solder having a high melting point. This was then scraped in to within 0.025mm using an accurately ground template, Fig. 9b.
