# 西安半坡

西安半坡博物馆编

# 半坡氏族居住区和建筑遗迹

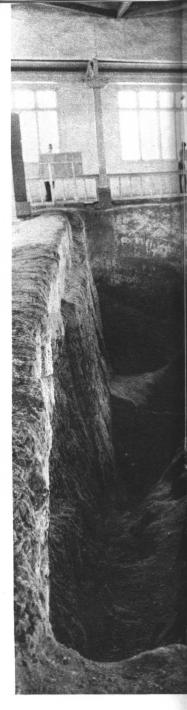
**4 大围沟** 宽、深各约五、 安全的设施(5)

Moat protecting the 300-metre long sector extended willage.

六米。环绕着居住区,是保护村落 存长300余米)。

village The moat, of which a ists, formed a circle round the

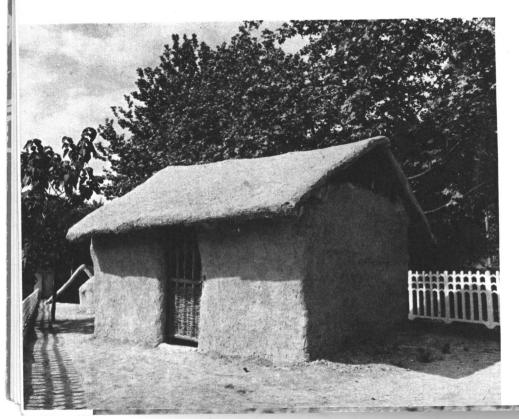
### 11 方形房屋复原

A rectangular cottage recovered

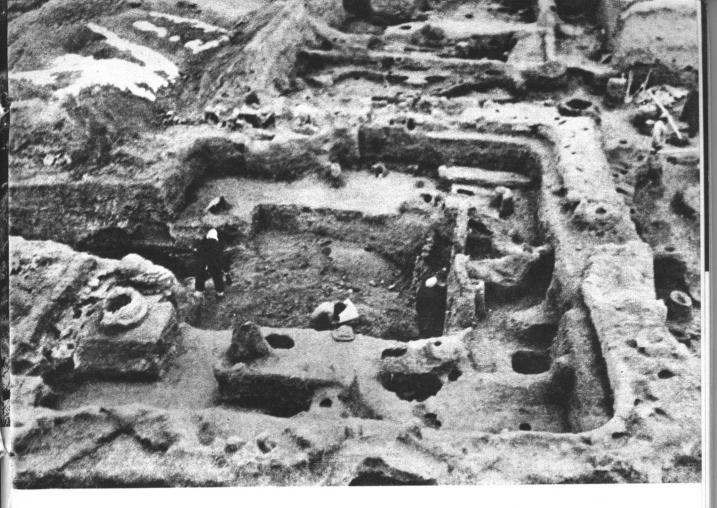
12 **一号大房子遗迹** 这是遗址中面积约160平方米的大房子。座落在村中心,是氏族集体 活动的场所,也是老人、儿童的住房。

Ruins of big shelter No. 1 With a space of approximately 160 square metres, the shelter at the centre of the village was inhabited by the aged and the children and also served as a place for gatherings.

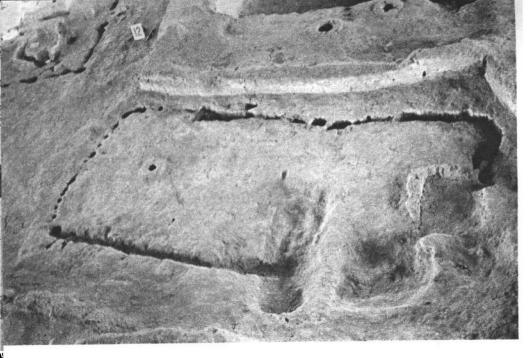
14 **配栏** 它的构筑形式与房屋不同,可能是饲养家畜的。东西长5.7米,南北宽2.5米。 **Ruins of a pen** Believed to be where the domestic animals were kept, the area is 5.7 metres in length and 2.5 in breadth.

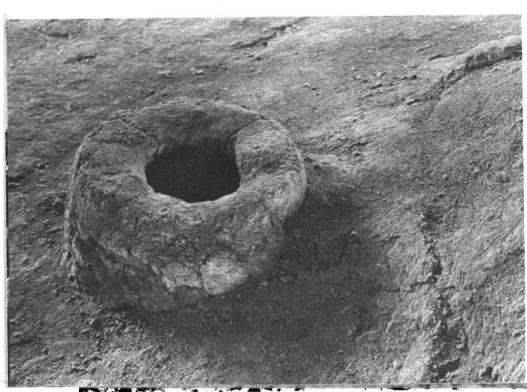
15 **硬土围柱洞** 这是用以加固柱子的硬土圈。柱洞内有夯打痕迹,底部垫有碎石、陶片, 土圈是烧烤过的硬土。它是我国建筑史上目前发现最早的柱础。

Clay holder of a post This is a ring of baked clay to hold a post supporting the roof. In the hole where a post was planted pebbles and shards have been found. There are signs of ramming. The whole thing is recognized as the earliest Chinese rodal of the plinth.

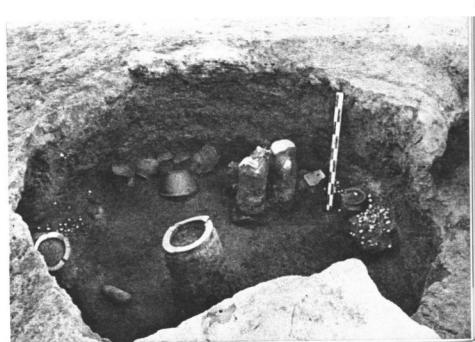
17 **地害** 是用于储存生活资料及用具的。共发现200多个,均分布在室外。晚期客形多为口小底大的袋状。

A storage pit All of the total of 200 such pits unearthed were out of doors. Those dugged out in the later stage of this village are in the shape of truncated cones, with the bottom much bigger than the mouth.
